WYCO Lake Retaining Wall Improvements

Geotechnical Engineering Report

January 26, 2023 | Terracon Project No. 02235265

Re: Geotechnical Engineering Report
WYCO Lake Retaining Wall Improvements
3862 West Drive
Kansas City, Kansas
Terracon Project No. 02235265

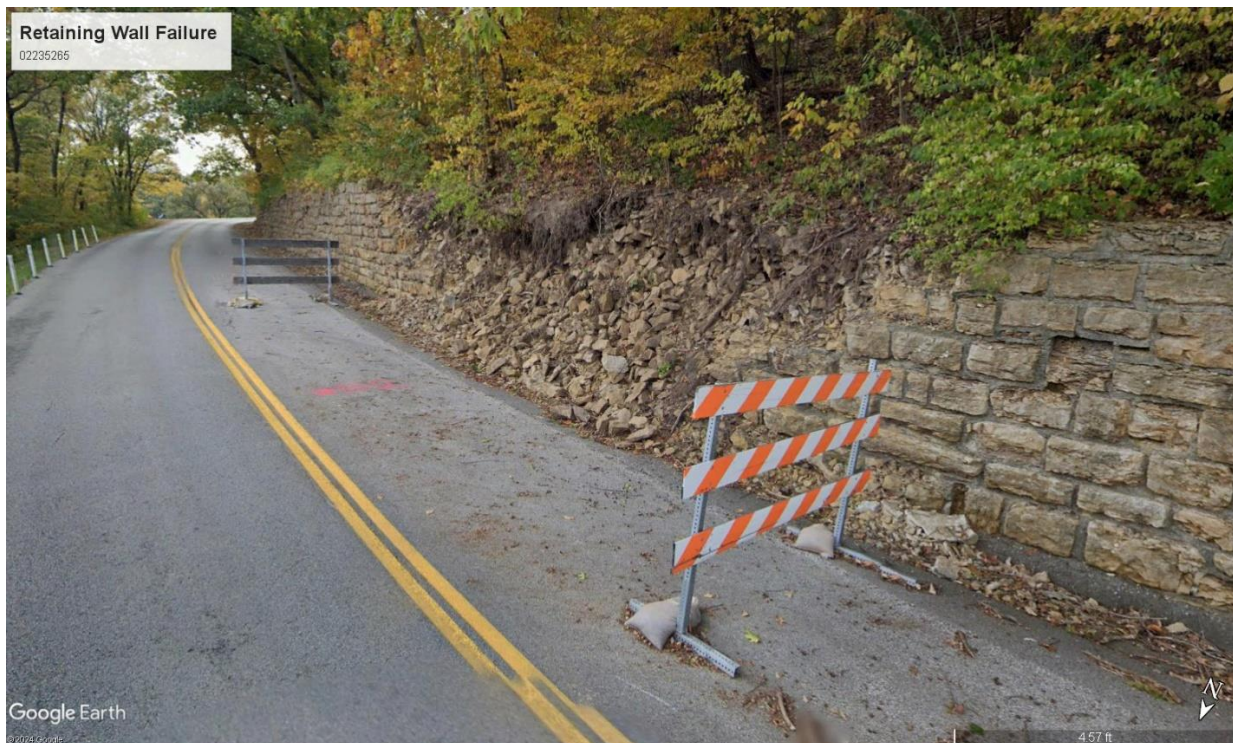
Picture 1

Terracon was contacted by WYCO Parks and Recreation (WYCOPR), in August 2023 to evaluate a retaining wall failure and possible slope failure (See Pictures 1 & 2) on the southwest side of Wyandotte County Lake in Kansas City, Kansas. Approximate Latitude/Longitude: 39.1593, -94.7930

Based on conversations with the client during the initial site meeting we understand the wall collapsed in February of 2023. It is believed the wall itself is approximately 75 to 85 years old, the lake and park are approximately 85 years old. We understand the lake was constructed on the location of a rock mine area where bedrock used to be mined for construction purposes. Based on conversations and recollections the client team, some cracks were noticed within the wall prior to the collapse.

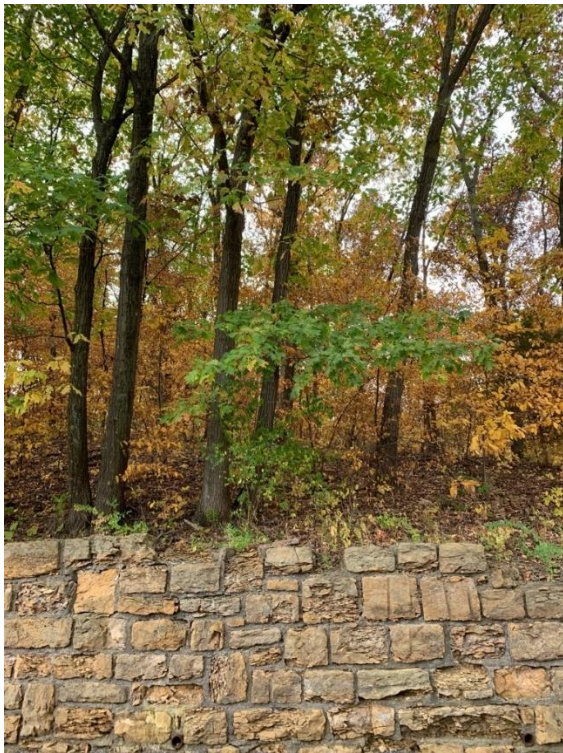
Picture 3

The retaining wall is comprised of limestone and sandstone blocks and has a maximum height of approximately 8 feet. As seen in the images below, the rock pieces used to construct the wall show evidence of weathering and fracturing. Existing trees in the slope area above the wall have been observed to be leaning in the direction of the wall, but no obvious signs of slope sloughing were observed. Further inspection of the wall revealed that several of the weep holes were obstructed/clogged with soil and rock, and it appeared that the backfill material behind the wall consisted of limestone fragments of various sizes.

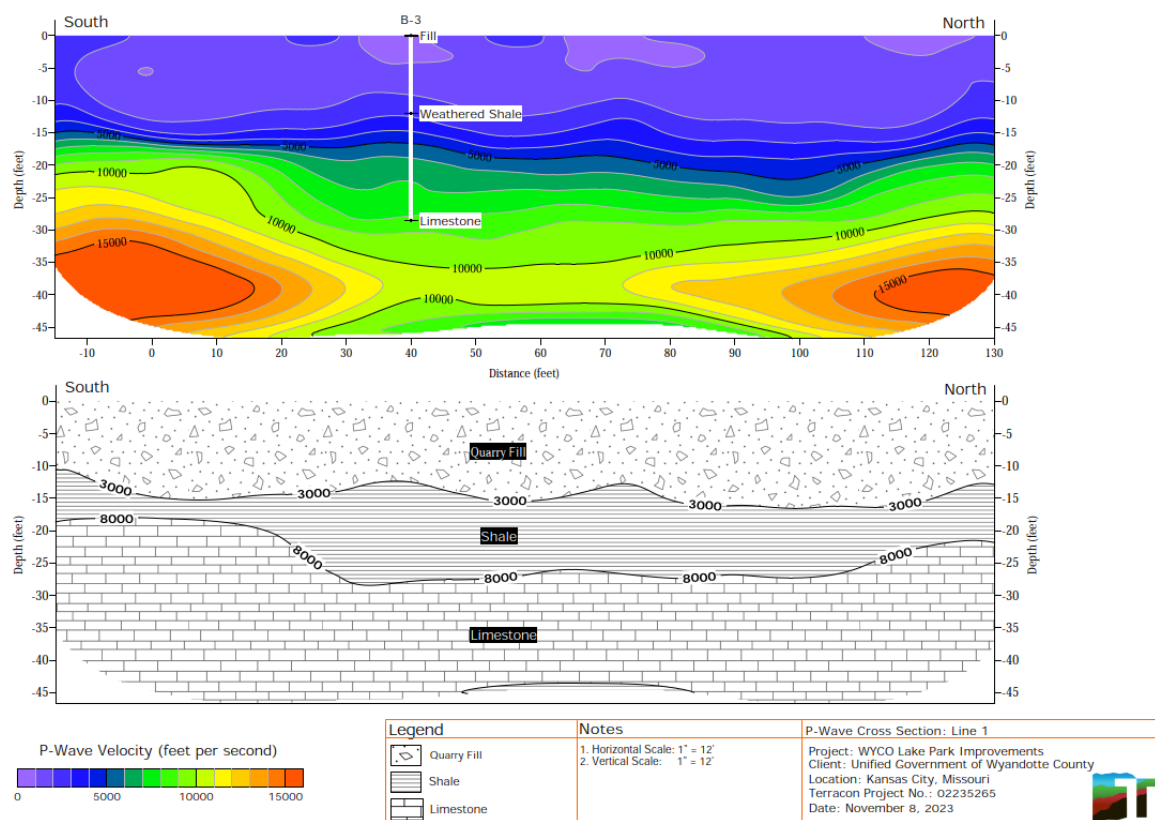
Figure 1: P-Wave Cross Section: Line 1

The following figures present the interpretations of the data from the geophysical field exploration. The velocity at which a p-wave travels through a material is mainly influenced by the density of the material. In general, lower velocity materials (violet) are interpreted to represent overburden and fill materials (relatively less dense); whereas, higher velocity materials (blue to red) are interpreted to represent bedrock (relatively more dense). The borings were overlayed on the seismic cross sections to constrain our interpretations of the geophysical models. Both the borings and the geophysical models were used to develop the global stability model described in the section below.

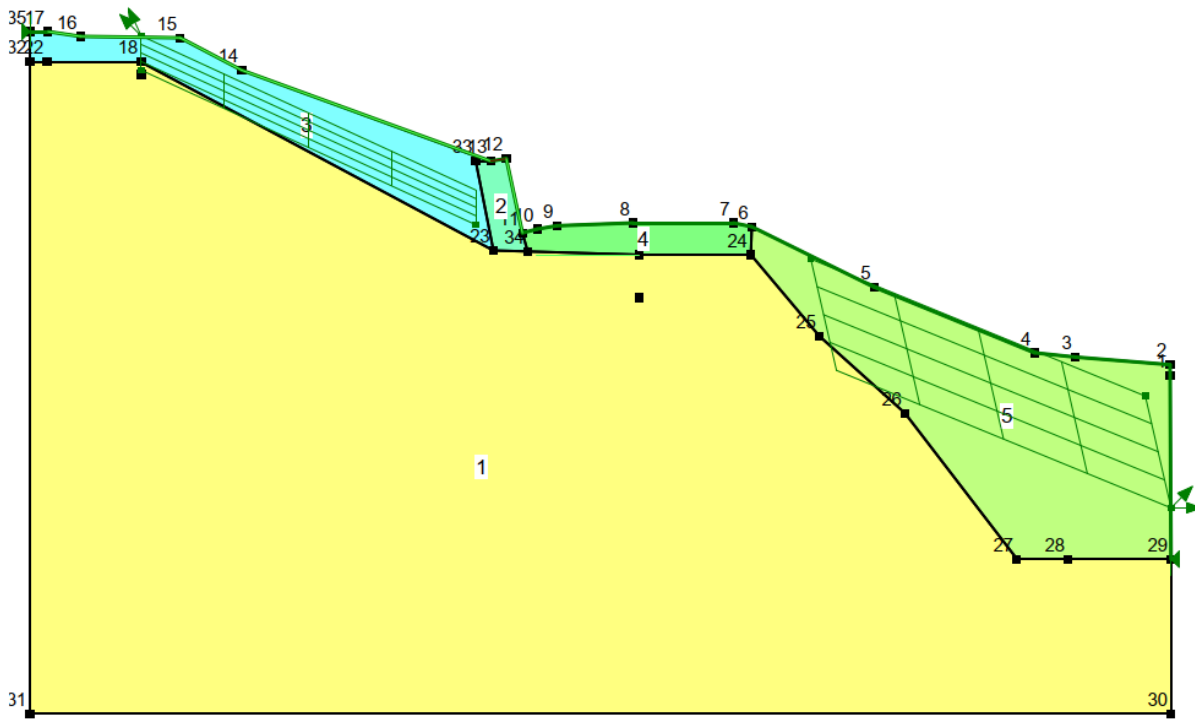
Figure 3 – Slope Configuration

Slope stability analyses were performed for impacted area of the wall. Parameters for the analyses were derived from our exploratory borings, experience with local soil and rock materials, and laboratory tests. Stability analyses were conducted using the computer program Slope/W developed by Geo-Slope International. Based on the analyses, the factor-of-safety for global stability at the analyzed cross sections was at least 1.5. Due to the nature of the slope we selected to run the analyses based on a block slope failure.

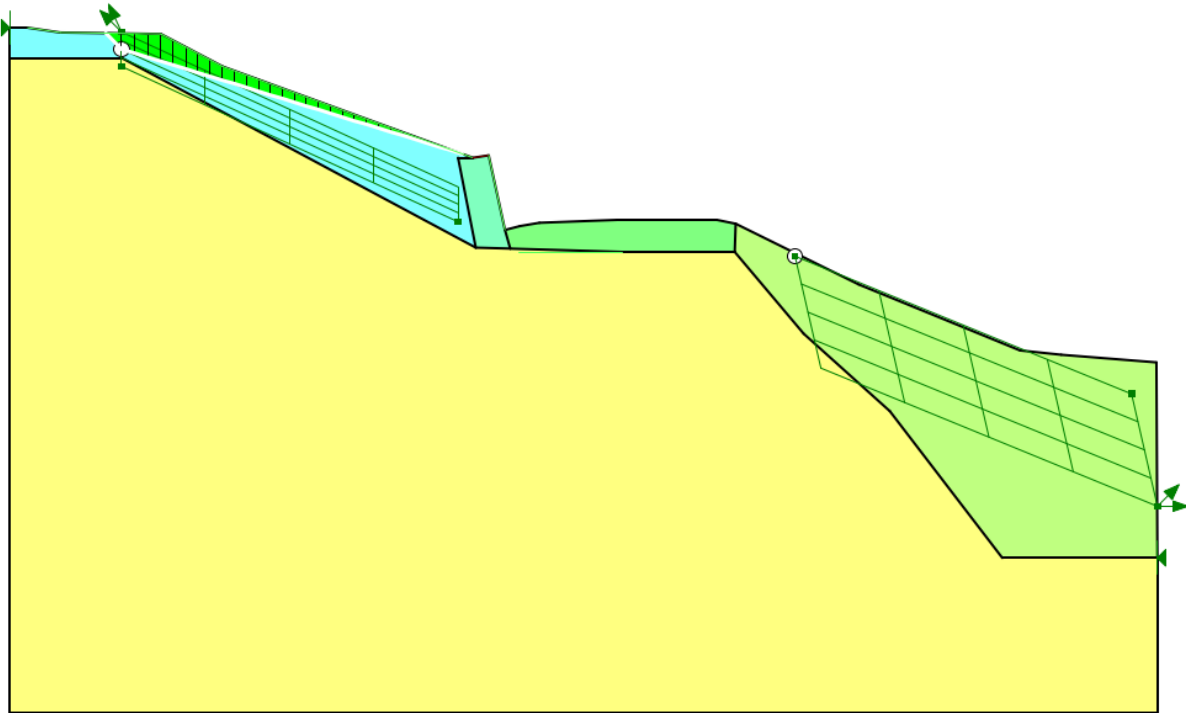
Figure 4 – Slope Analysis Cross-Section

The global stability analysis performed indicated that the in general the slope is in stable condition. The failure of the wall appears to be a localized failure of the retaining wall. The reason the retaining wall collapsed was not determined and is outside of the scope of our investigation. However, based on our observations and experience the following causes may have contributed individually or as a group in its collapse:
