WYCO Lake Retaining Wall Improvements

Geotechnical Engineering Report

January 26, 2023 | Terracon Project No. 02235265

Re: Geotechnical Engineering Report
WYCO Lake Retaining Wall Improvements
3862 West Drive
Kansas City, Kansas
Terracon Project No. 02235265

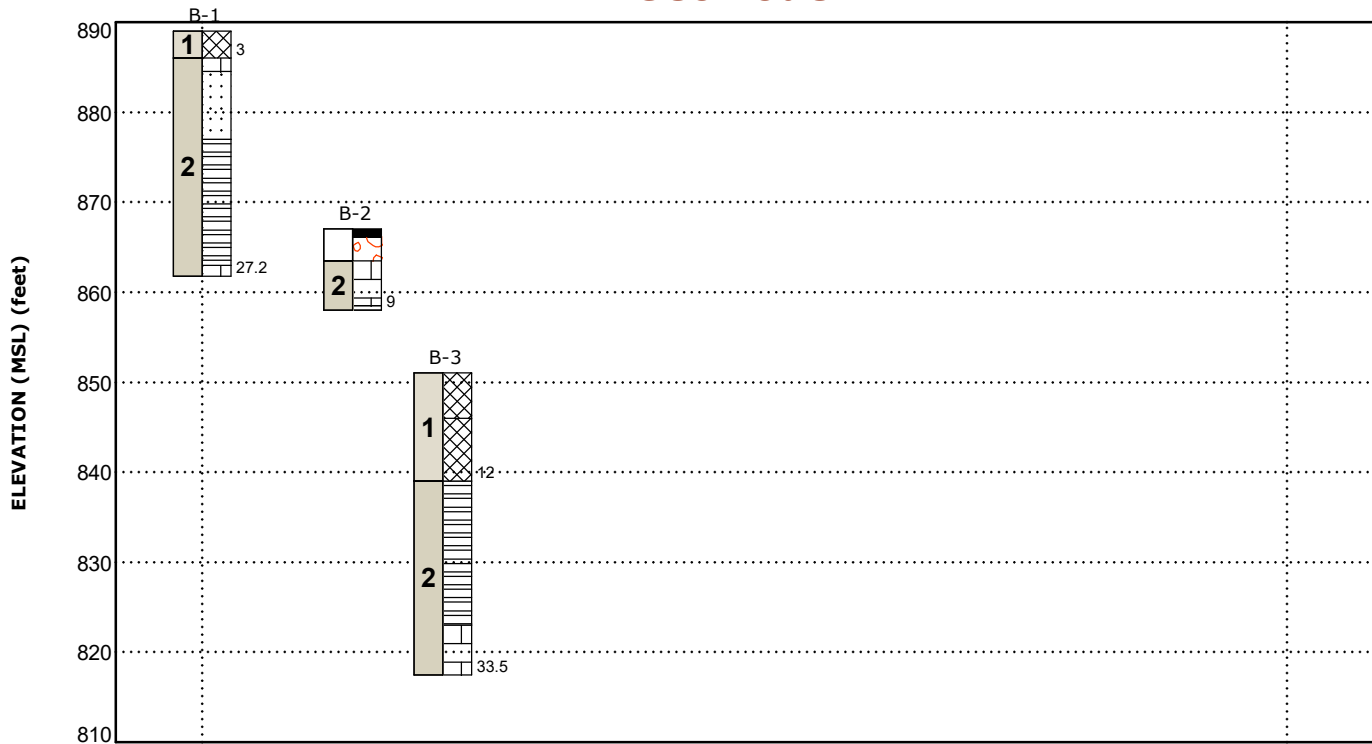
GeoModel

Model Layer	Layer Name	General Description	Legend	
1	Existing Fill	Loess clays and Glacial Till lean to fat clays	Fill	Limestone
2	Bedrock	Highly to moderately weathered limestone, Moderately weathered sandstone, and Moderately weathered shale	Sandstone	Shale
			Asphalt	Aggregate Base Course
